Interim Progress Report for the
AAA-SRJC-NBEAA
State-of-the-Art Electric Vehicle Conversion Project

Steven Cohen, Dean of Business and Professional Studies, Santa Rosa Junior College
Chris Jones, Chapter President, North Bay Electric Auto Association
Updated May 25, 2011

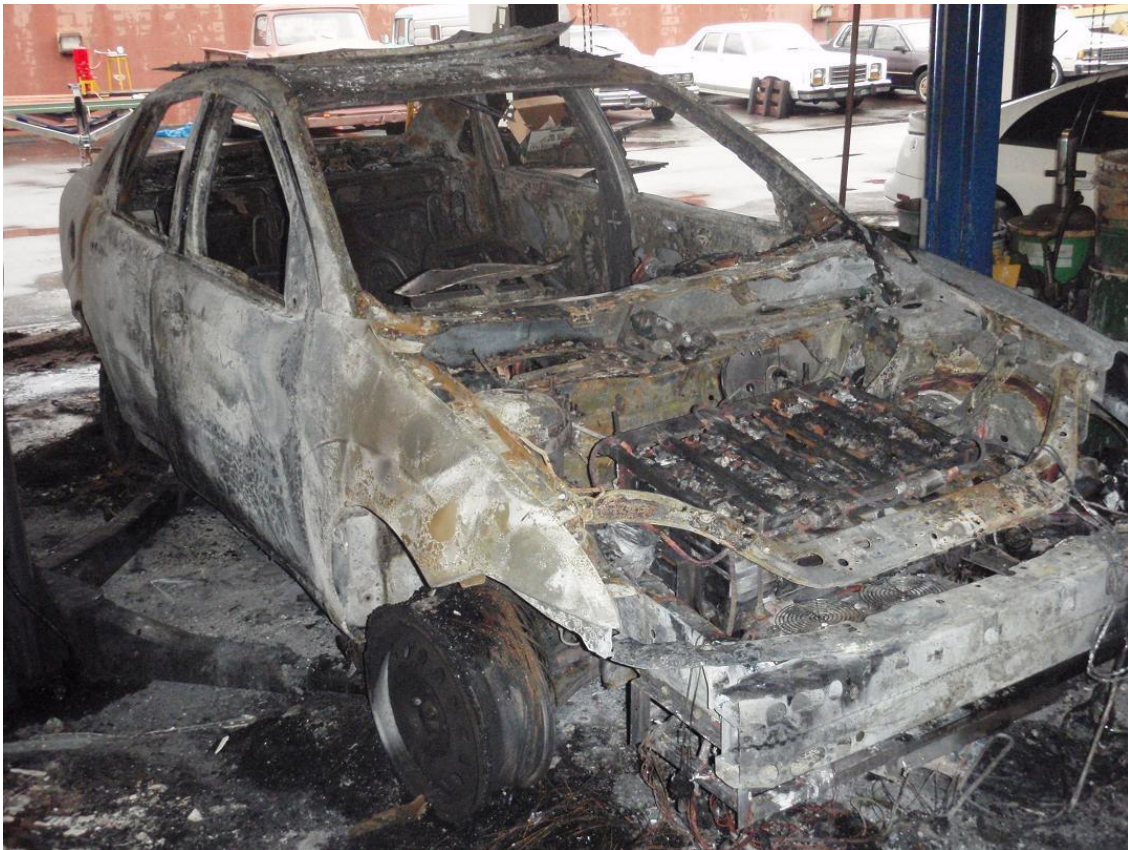
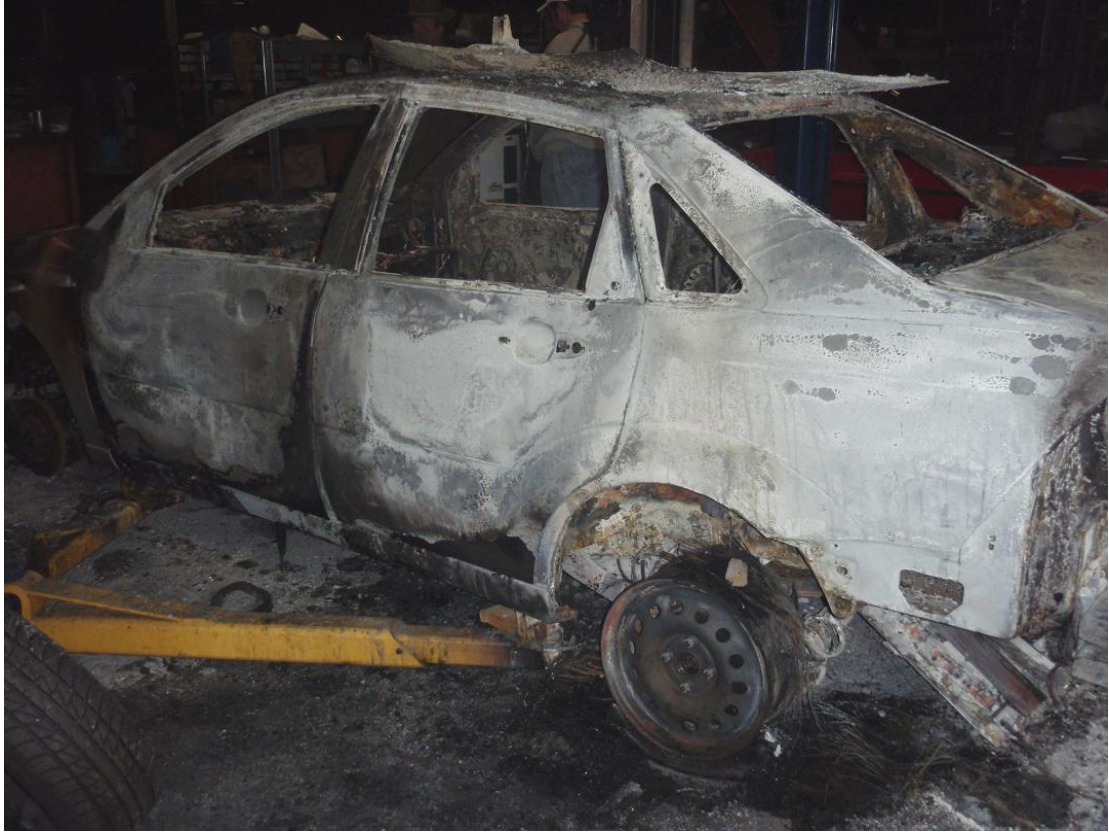
11. The traction battery pack was energized for the drive and charge system tests and left connected at ~298 volts starting on March 12th 2011. Prior to that the pack had been fully connected a few times, but not left fully connected when unattended.
12. Car burned around 10 PM Friday night March 18th 2011. Smoke detectors kept getting set off by gas engine exhaust so heat sensors were installed, but not connected to the sprinkler system. Alarm system went off, but was not connected to any communication system, so no one heard it. Finally someone reported smoke passing by and the fire department arrived about 11 PM, but the fire was almost out, it only took 50 gallons to extinguish the fire. Nearly all plastic, rubber and paint was burned, and the lift and garage door was damaged. The rest of the shop was filled with soot, but otherwise no other damage. Here are some pictures of the car:

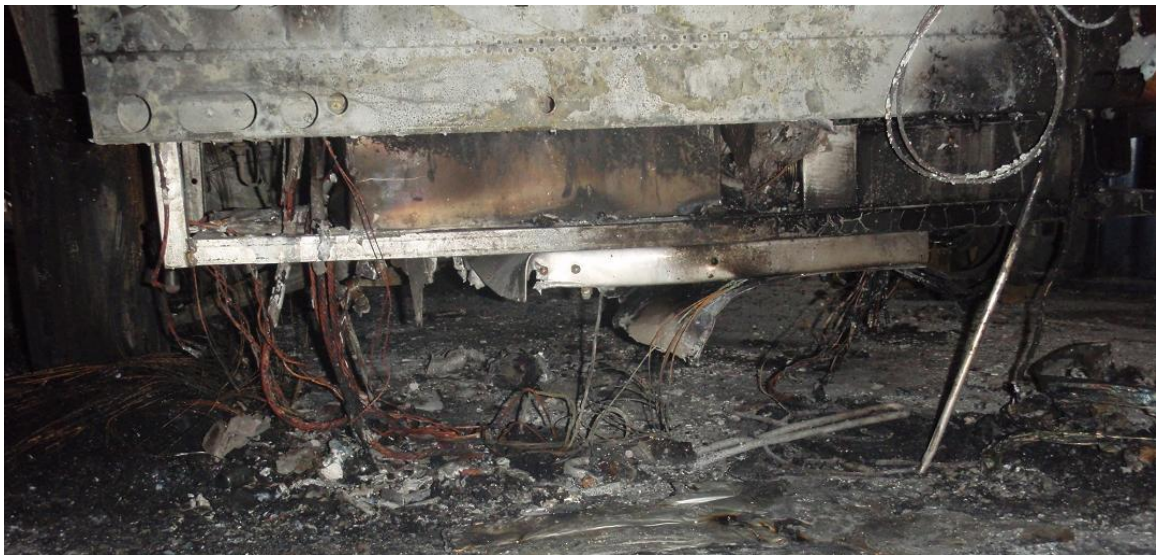
These loads are located only a few inches away from the front batteries with no firewall between them and could have caught fire. But this is not likely since the DCDC converter has a relay that disconnects it from high voltage when off, all three components appeared to still be in tact after the fire, inferring they were not at “ground zero” of the fire. Here is a picture of the motor controller, charger and DCDC converter attached on top of the radiator assembly rack:

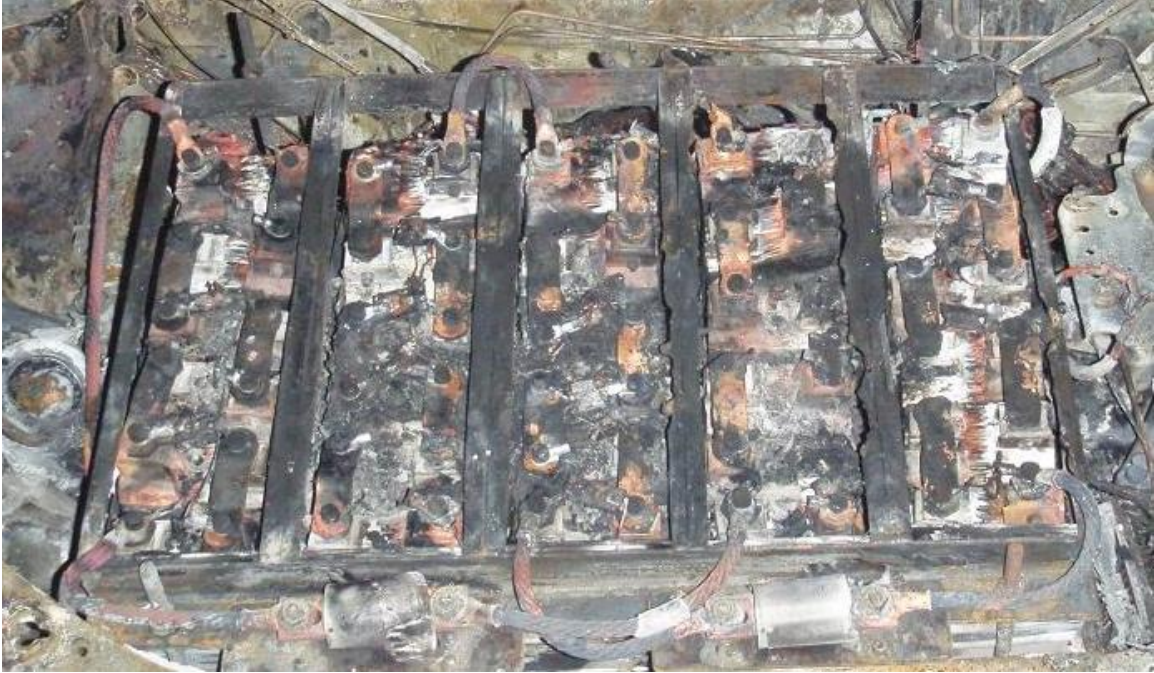
Both the junction box and front battery rack have non-insulated high voltage terminals spaced between 2 and 10 Volts per millimeter (V/mm) vs. 1 V/mm recommended by Bill Dube of KillaCycle, who holds the world electric motorcycle speed record, in a post to the EV Discussion List on March 23, 2011. His post is reprinted here:

a. The front batteries, with areas up to 10 V/mm, were covered with rubber strips made from cut car inner-tubes to protect passersby from electrocution hazard, so a falling object was less likely to cause a fire, but an exploding component on a BMS cell board, or a wet rodent or dry one carrying a conductive wire to make a nest crawling under the rubber, may have caused a fire. The picture below shows how badly burned the front batteries were, inferring that they may have been near the start of the fire:

1. Space all exposed high voltage $<1V/mm$. Insulate all others.
2. Put a firewall between the batteries and its loads.
3. Do not put batteries in a place where they would move during a collision in such a way that could cause accidental shorting.

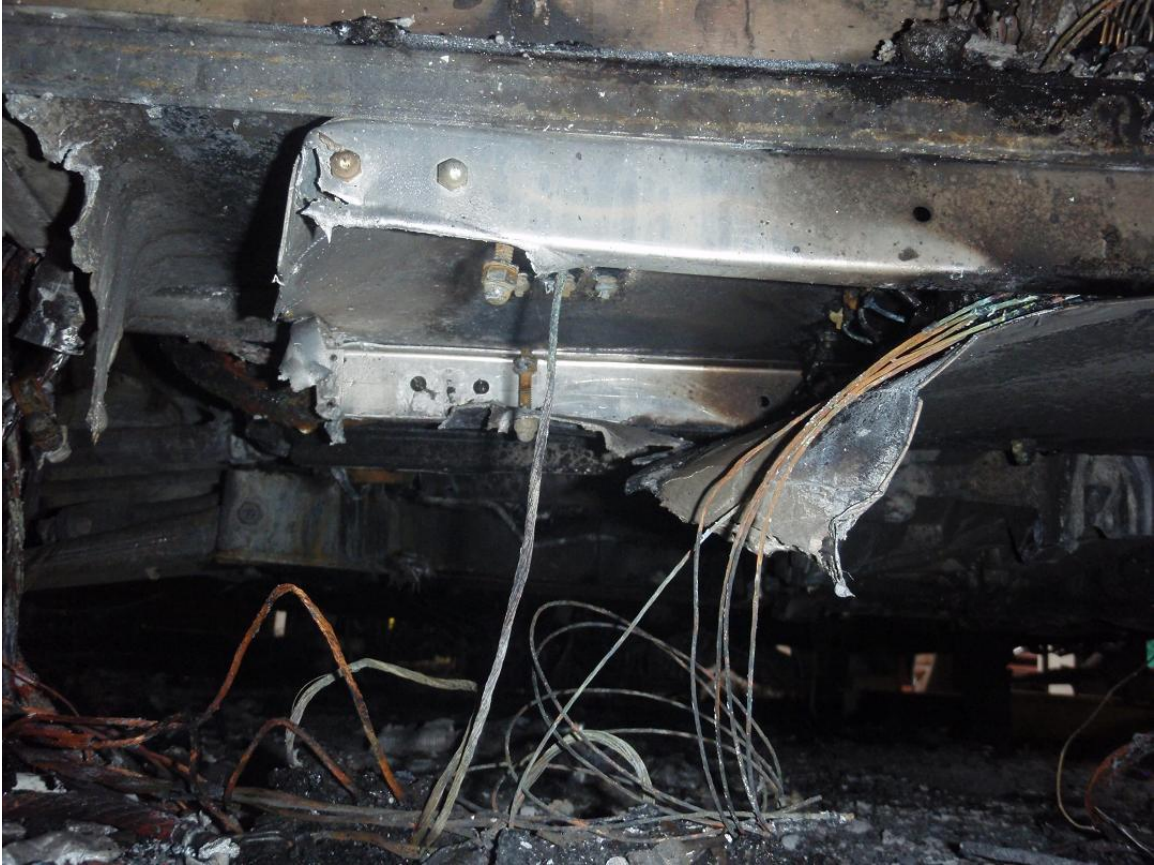
b. The junction box, with areas $>2V/mm$, was enclosed with no potentially volatile components near it such as circuit boards, but per the picture below, its lid is peeled back, possibly due to the high heat of a fire inside:
